**STATUS REPORT ON STRUCTURAL
ADEQUACY OF**

**JAY CHAMBERS CO-OPERATIVE
PREMISES SOCIETY Ltd.**

**PLOT NO. 357, TPS NO. V,
Dayaldas Road,
Vile Parle (East),
Mumbai-400057**

DATE: 02 / 02 / 2024

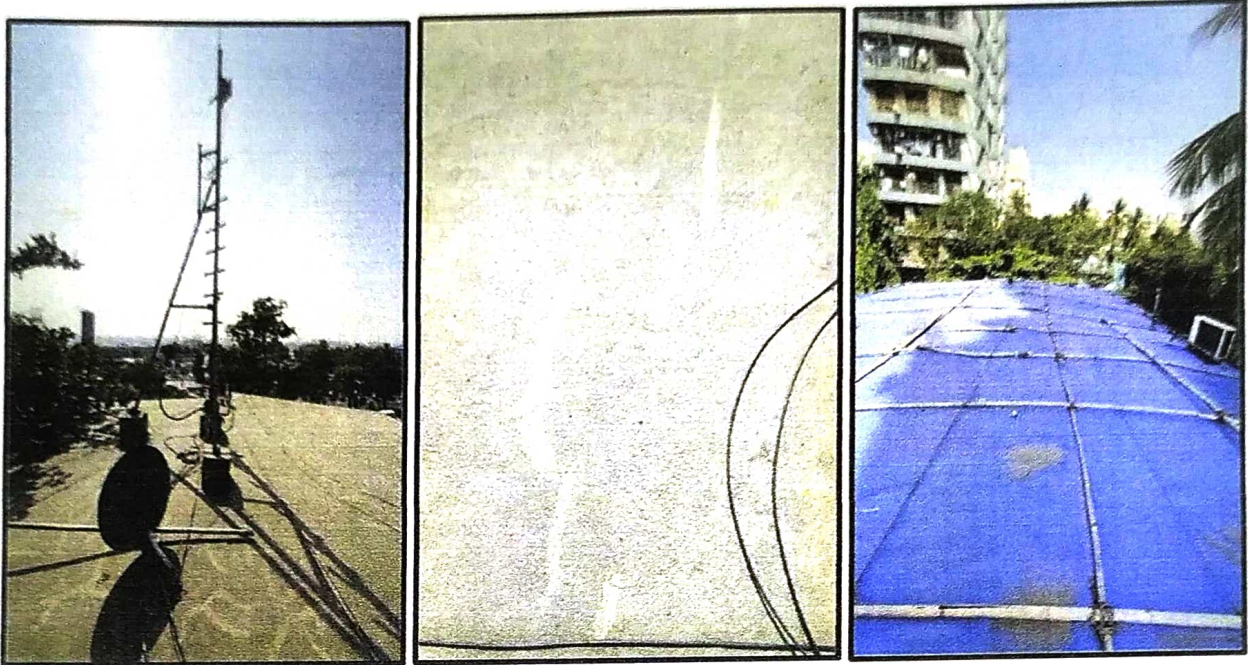
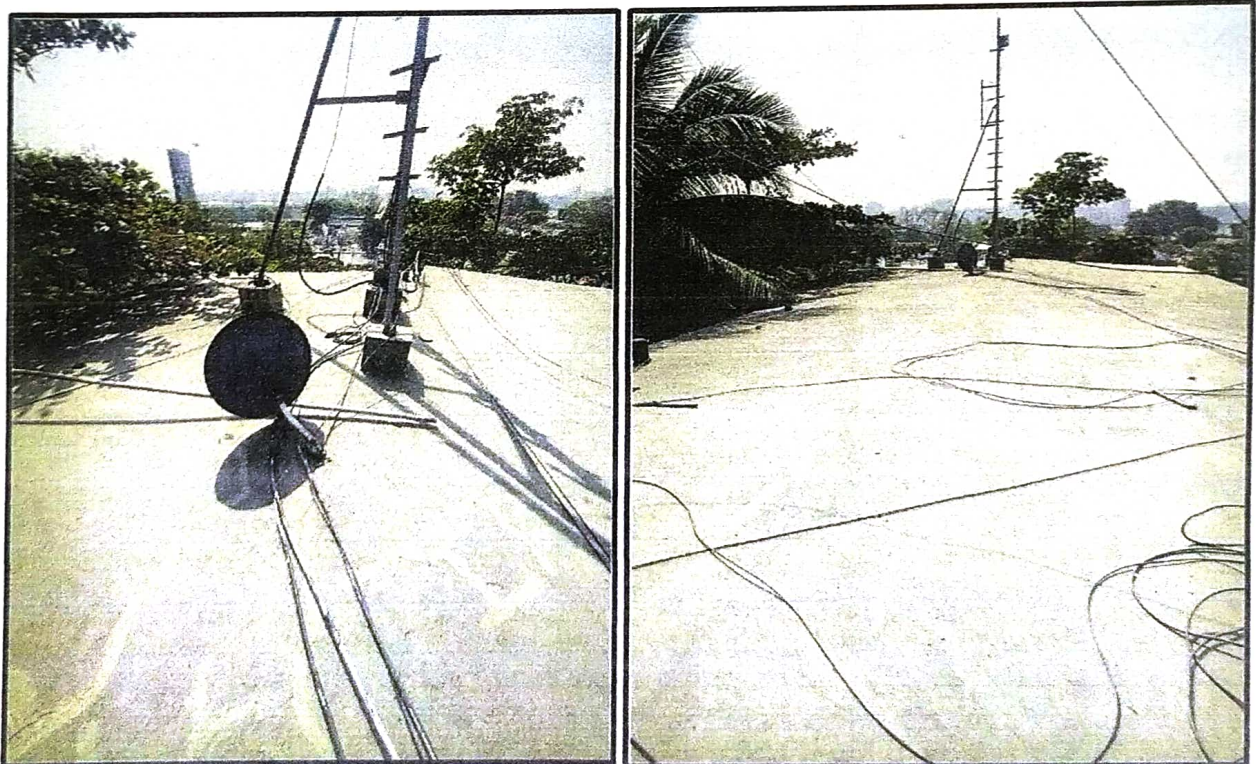
➤ TERRACE

- The roof of the building is accessible from A wing. A M.S. staircase has been installed on the top floor of the A wing to access the roof.
- Part terrace was covered with plastic sheets. On the other half, IPS was observed. Crack filling was done on the IPS.
- A mobile tower was observed on the roof of the building.

- The terrace is beyond repairs. There is no waterproofing existing on the roof slab.
- Due to the presences of cracks on the roof slab, lots of leakages are observed in the below units.

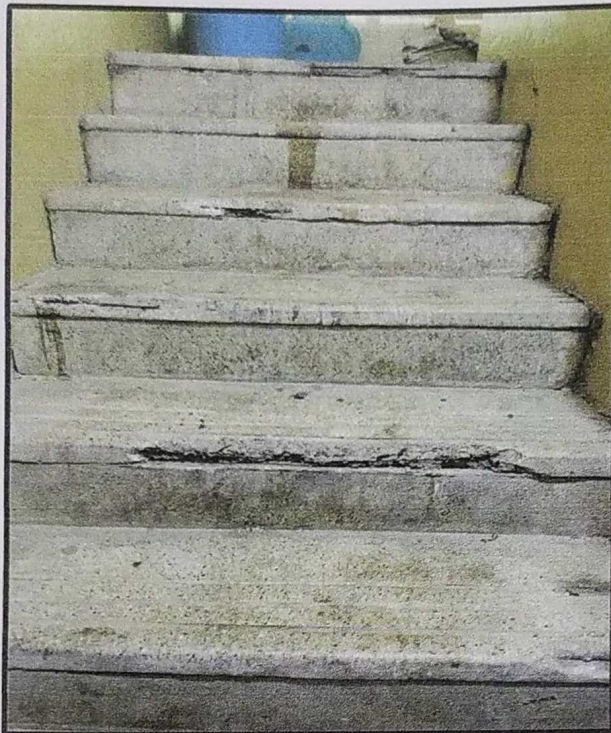
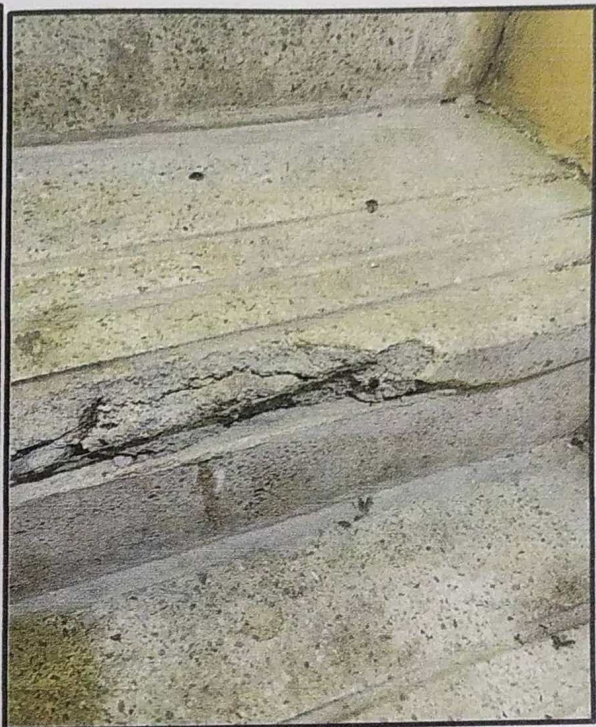
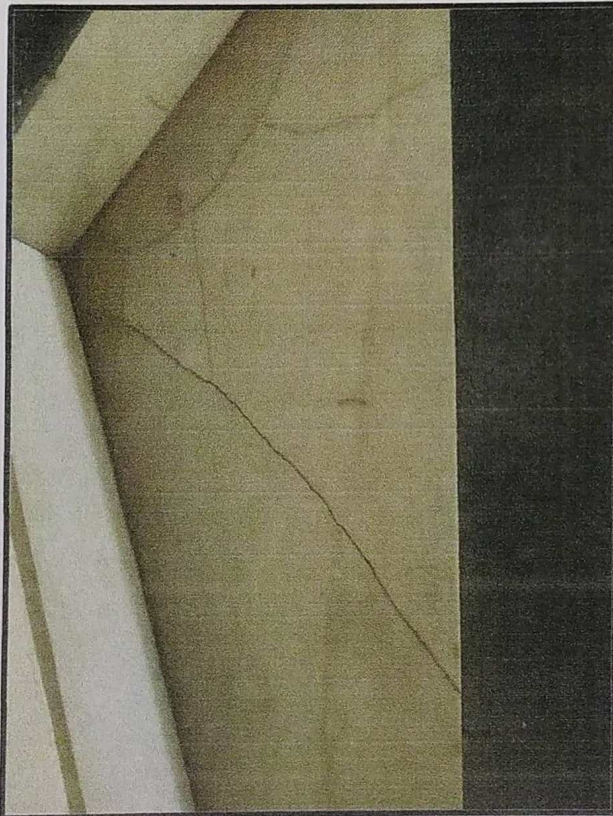
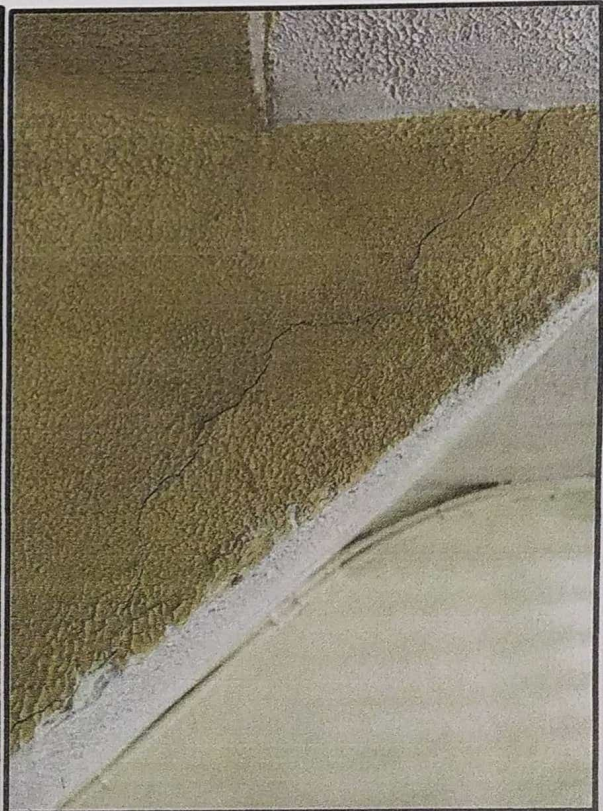
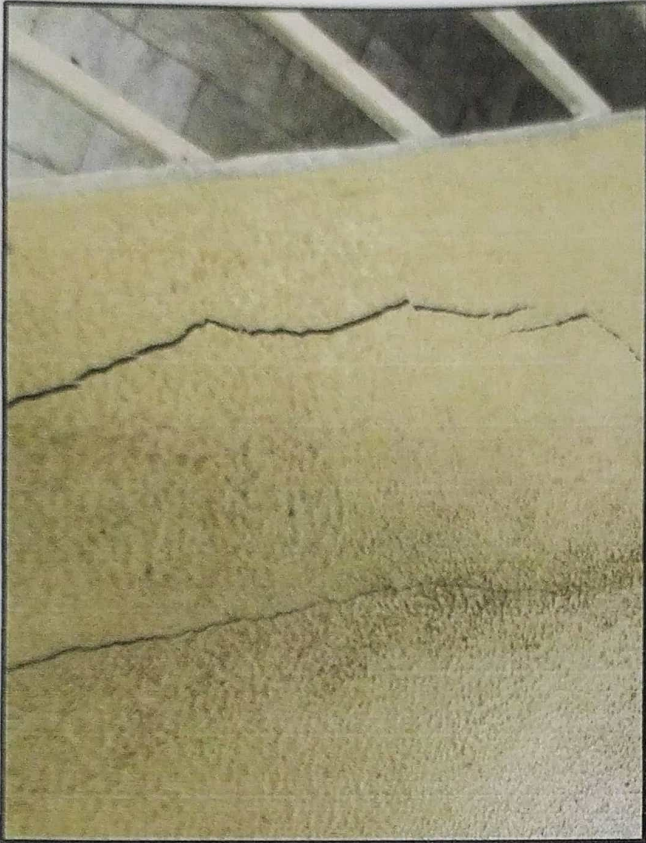
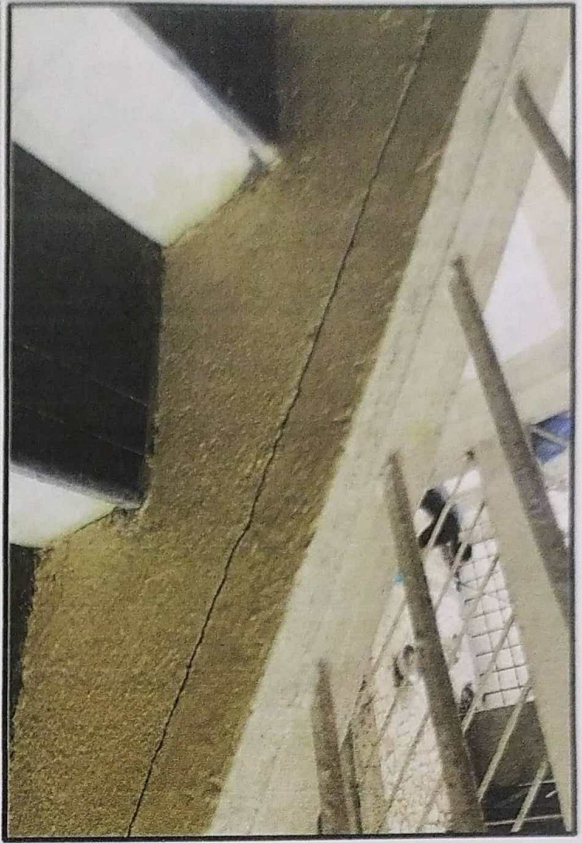
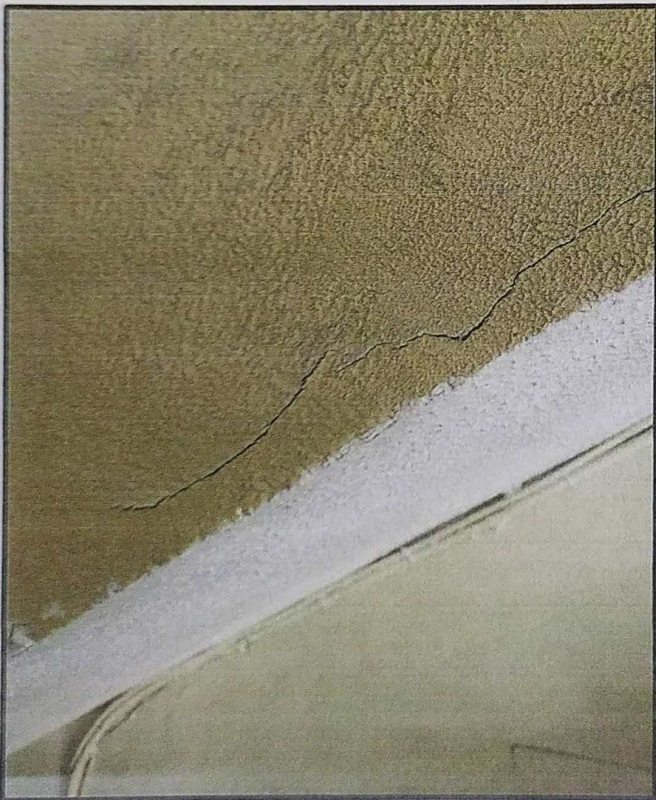
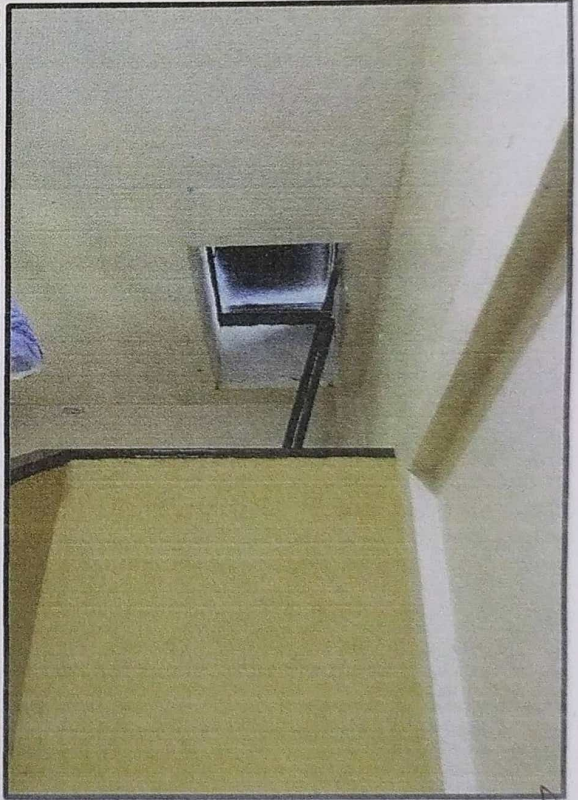
➤ STRUCTURAL DISTRESSES IN STAIRCASE AREA.

3.1: Structural cracks have developed on the waist slab of staircase. There is possibility of collapse of the plaster of the waist slab as at some places plaster is debonded with RCC waist slab.

3.2: The R.C pardsies have developed cracks at some places.

3.3 The R.C columns supporting the staircase have developed major structural cracks at some places.

3.4: The Jali at mid landing level has also seen broken at many places.

3.5: The plaster of head room ceiling on the stair case has also debonded and given its way exposing the reinforcement of the slab.

3:6: The marble treads on the staircase are found to be broken at many places.

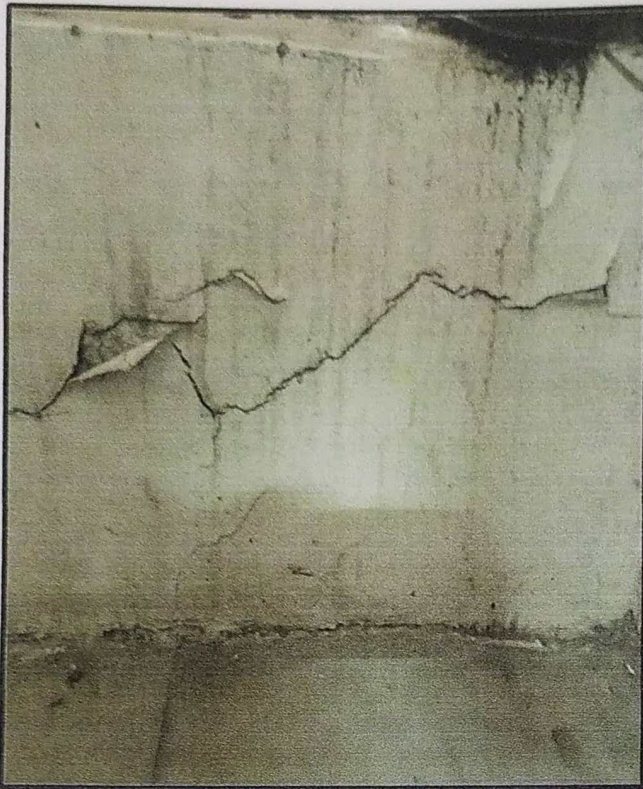
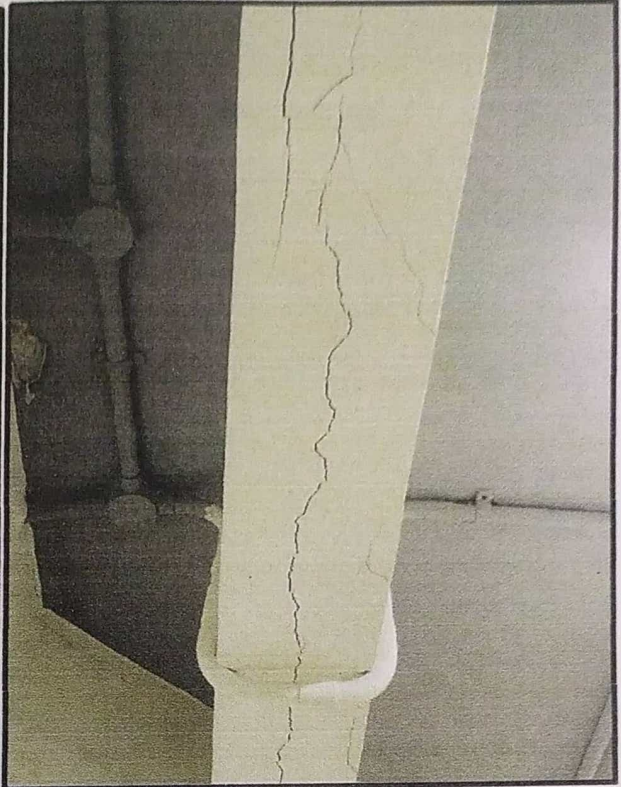
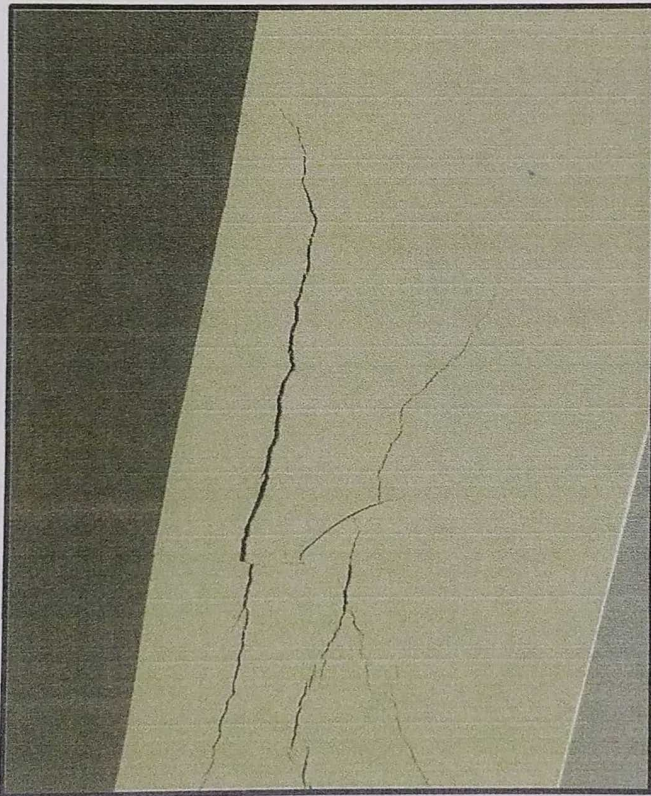
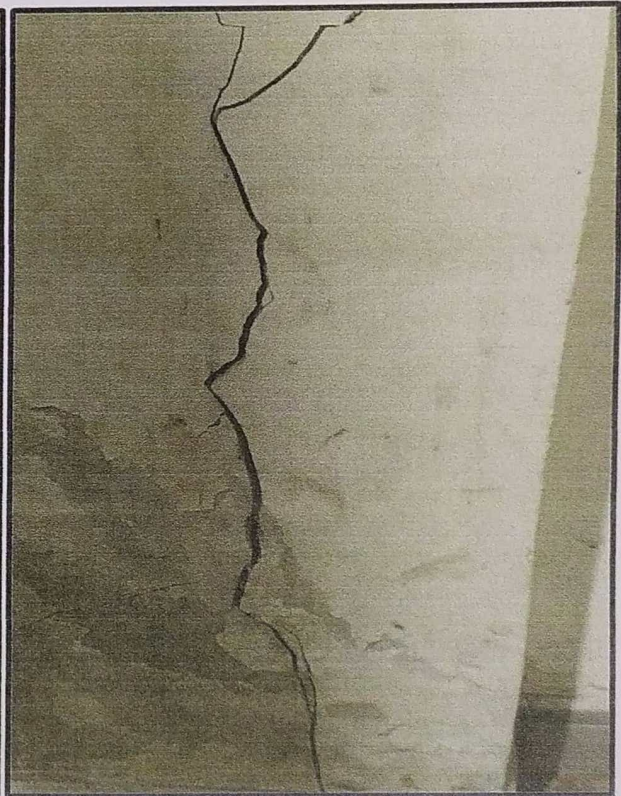
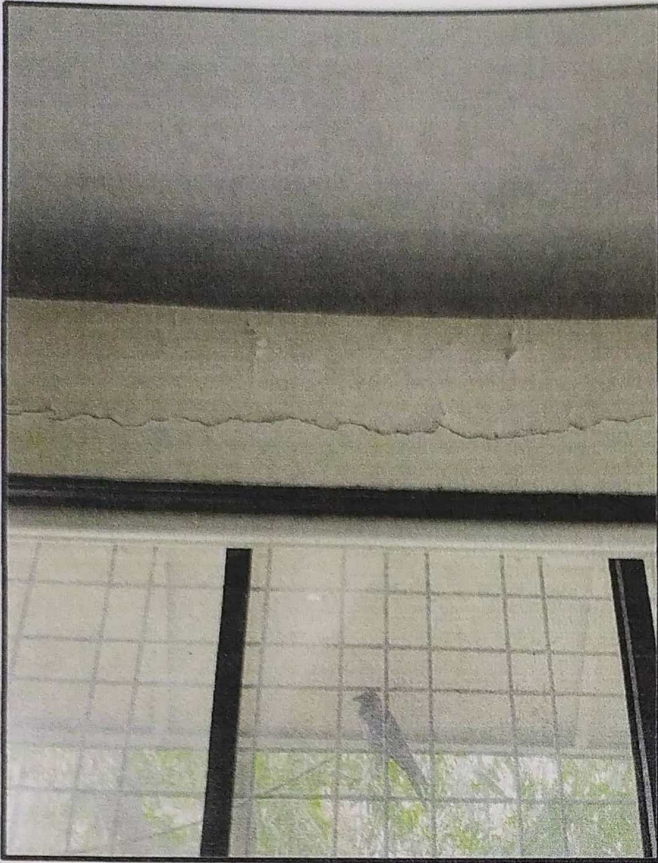
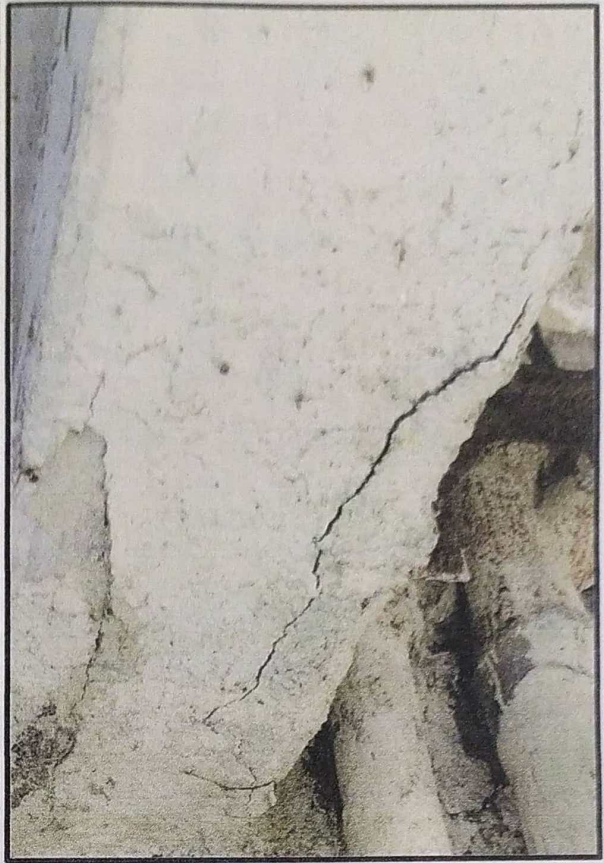
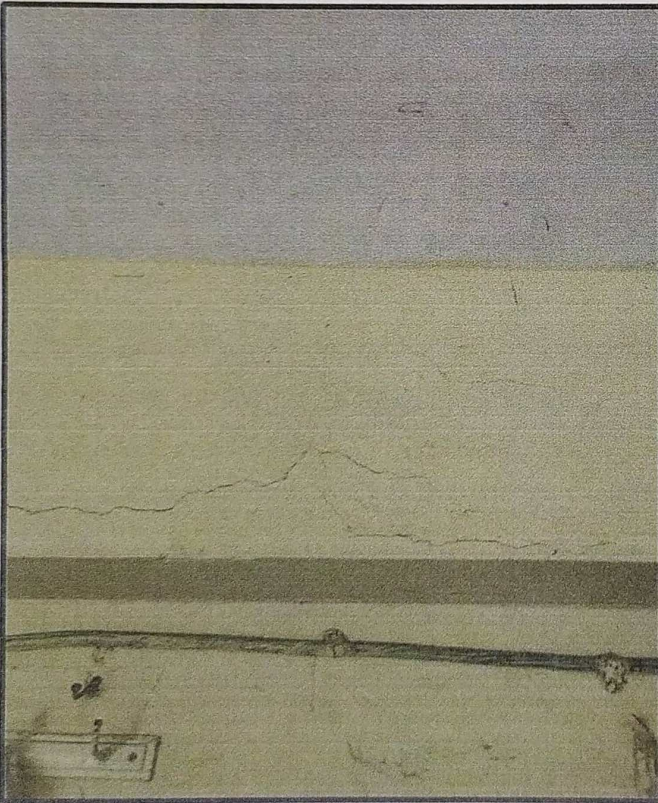
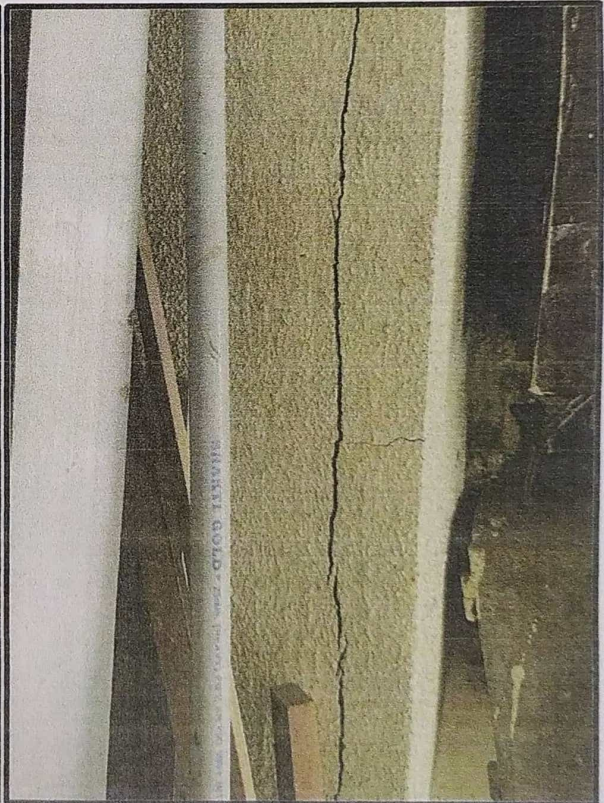
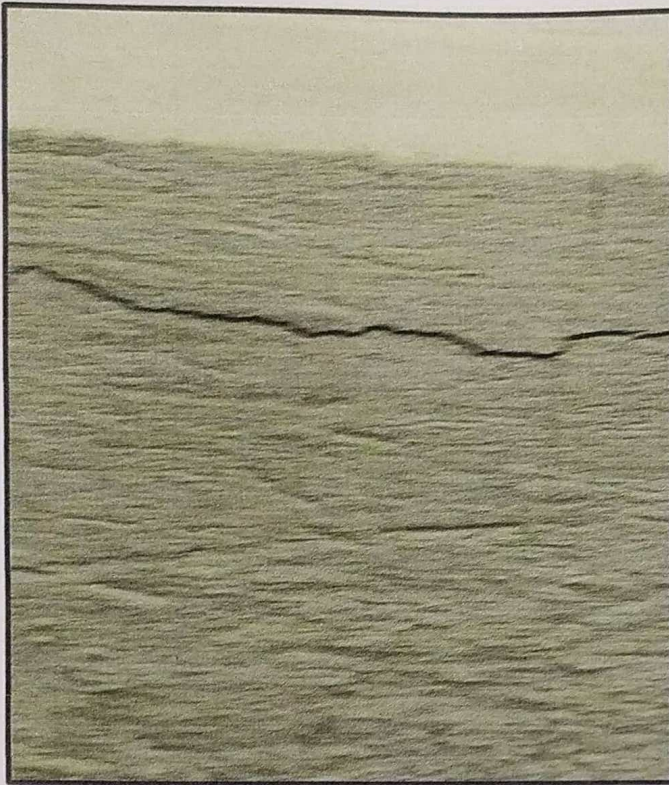
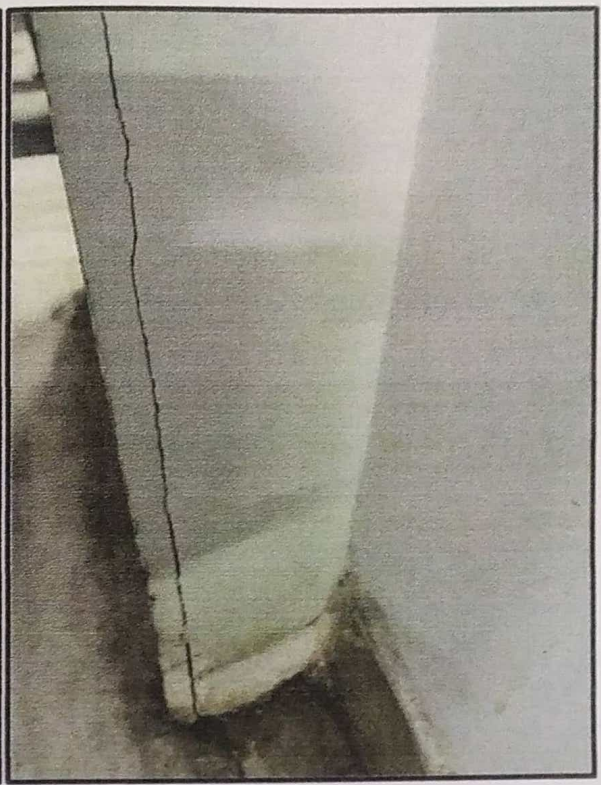
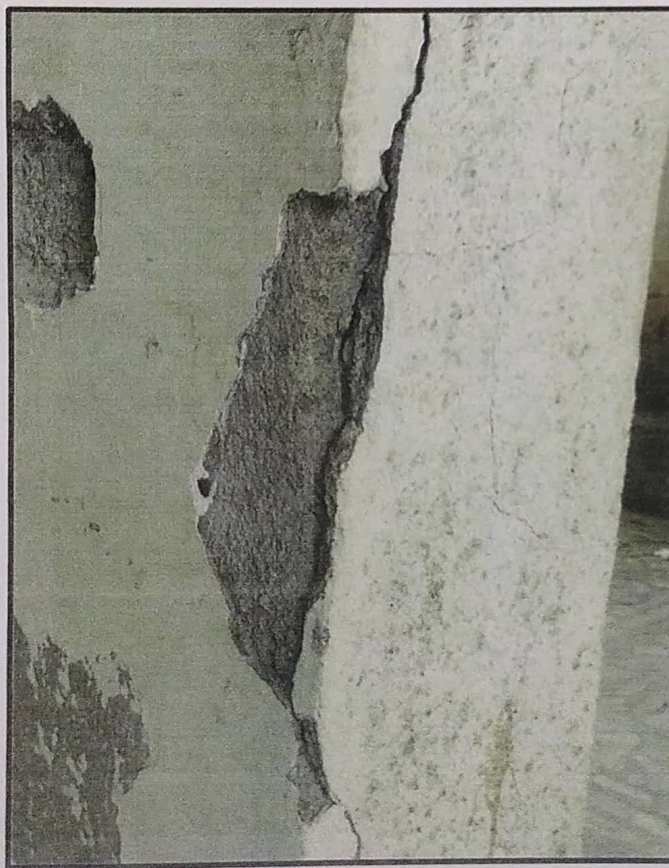
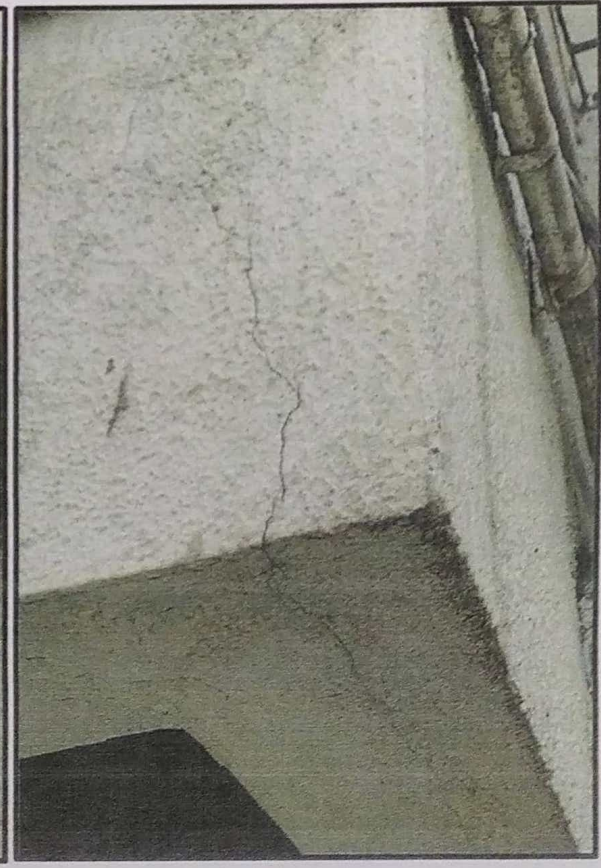
➤ STRUCTURAL DISTRESSES IN INTERNAL COLUMNS AND BEAMS.

The RCC members like columns, beams, slabs inside the flats are in **seen with major structural distresses**. Vertical & horizontal cracks and de-bonding were seen in the columns, beams and ceiling in some of the flats from inside .

Seeing to the damage of exposed RCC members like columns and beams, it is most likely that the structural members inside the wooden panels are also damaged extensively.

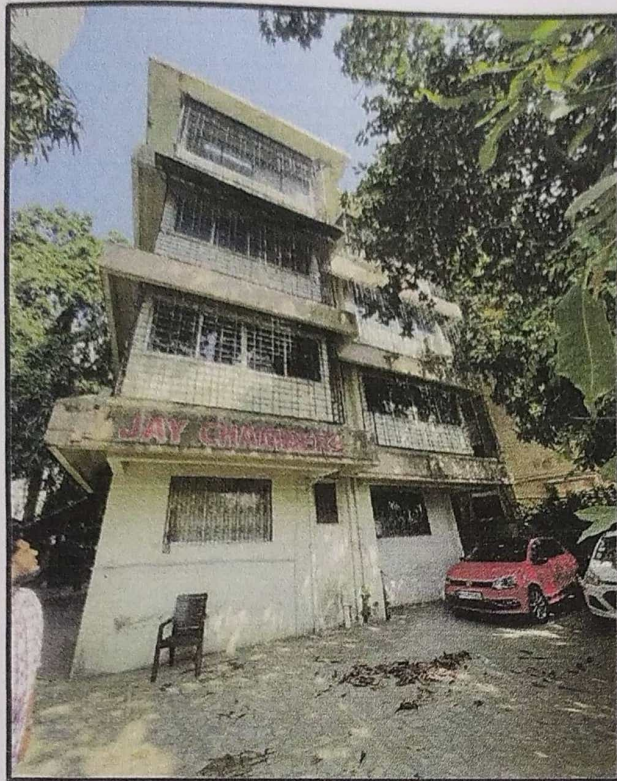
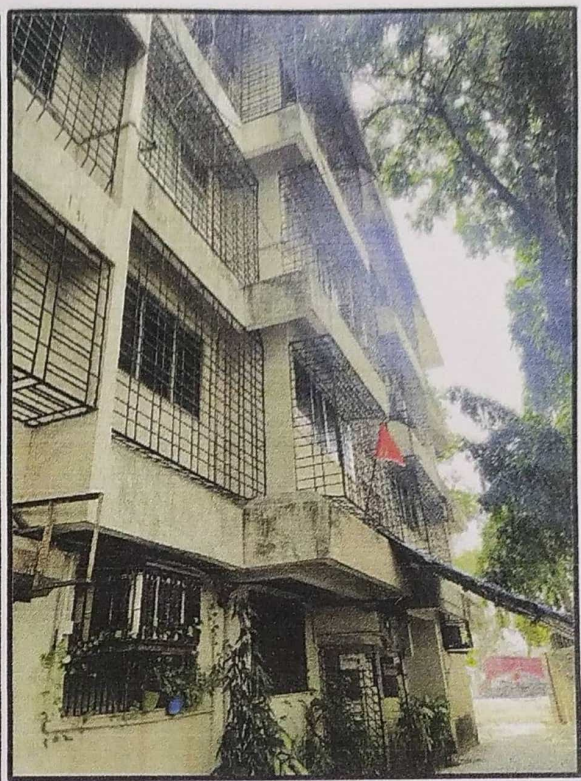
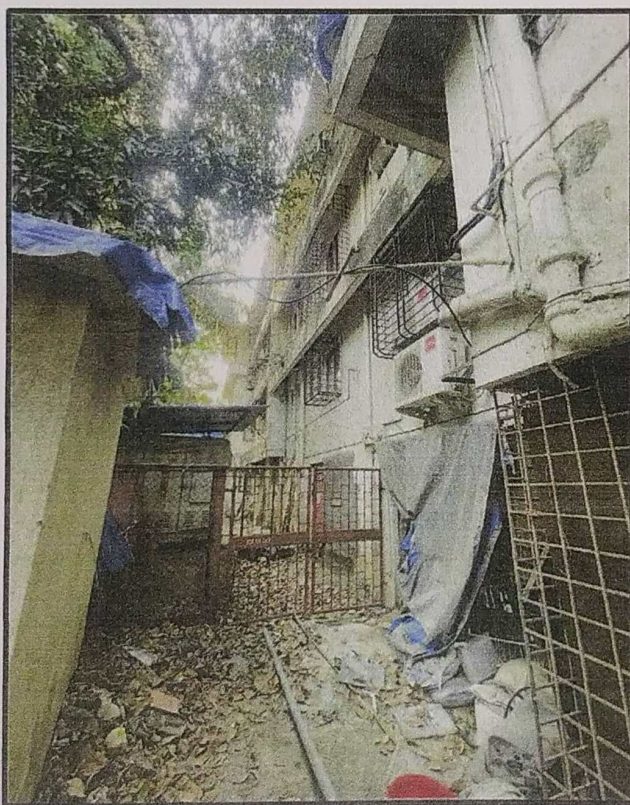
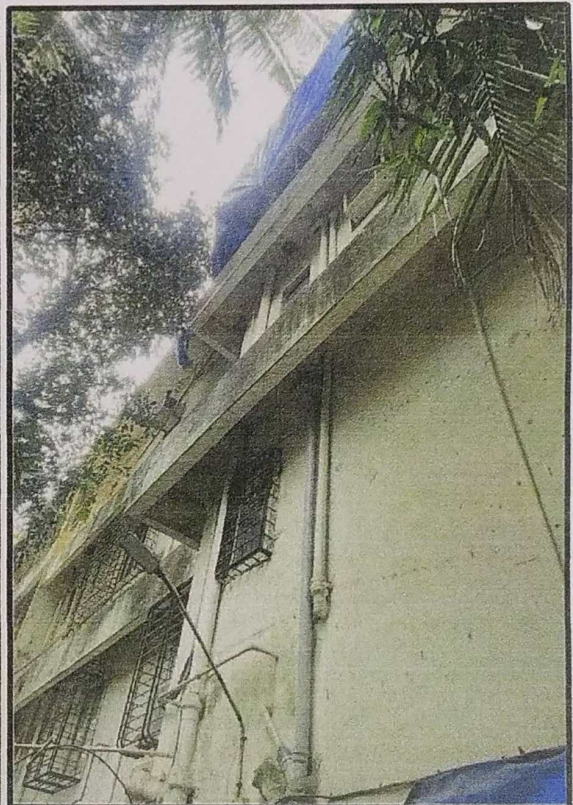
EXTERNAL FAÇADE

2.1: External inspection of the building shows that conditions of existing columns and beams have developed major Structural Cracks at some places.

2.2: Separation cracks in beam and column junctions are seen at many places.

2.3: Leakage and dampness is present in some of the external walls of the building, which is evident from the peeling of the paint.

2.4 The walls along the West & South side of the buildings are more affected as they are facing the general direction of monsoon rains and are hardly protected from the rains. Due to such seepage of rainwater through these cracks there is a possibility that the reinforcement may corrode forming loose scales. Existing **condition of external plaster is not satisfactory.** Major leakages & seepages have been found inside units particularly in rainy season.

2.5 The chajjas at floors level have developed major structural cracks at some places. Due to rusting of the bars the concrete area has given its way.

2.6 The external sand face plaster show hollowness (debonding from parent surface) at few locations.

2.7 The existing paint system is seen to have fully out-lived its water repellent property, by virtue of its age. Corrosion cracks are seen at few locations

strongly indicating highly corroded reinforcement bars inside the elements. Peeling of paint along with moss attack is also observed a

2.8 In general the existing external plaster of the building is showing varieties of damages in the forms of plaster cracks, separation cracks, hollowness in the plaster, external paint peel off, dried patches of fungus growth etc.

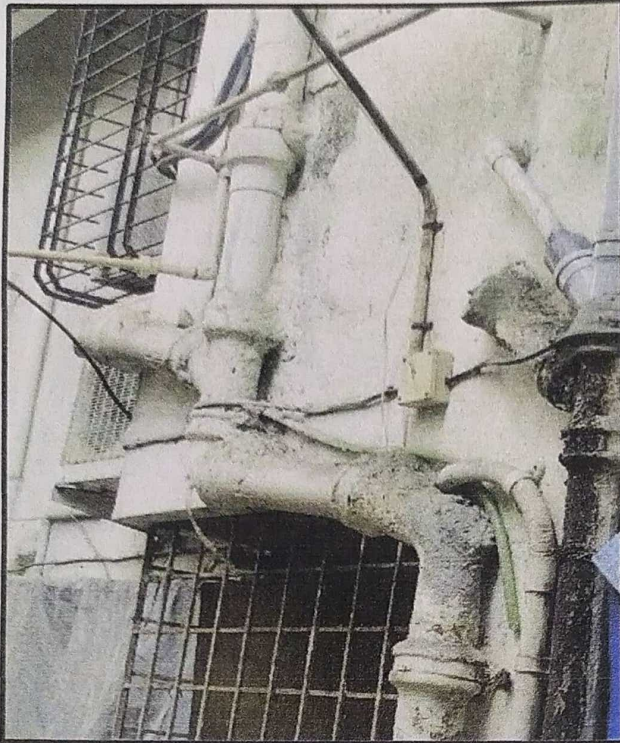
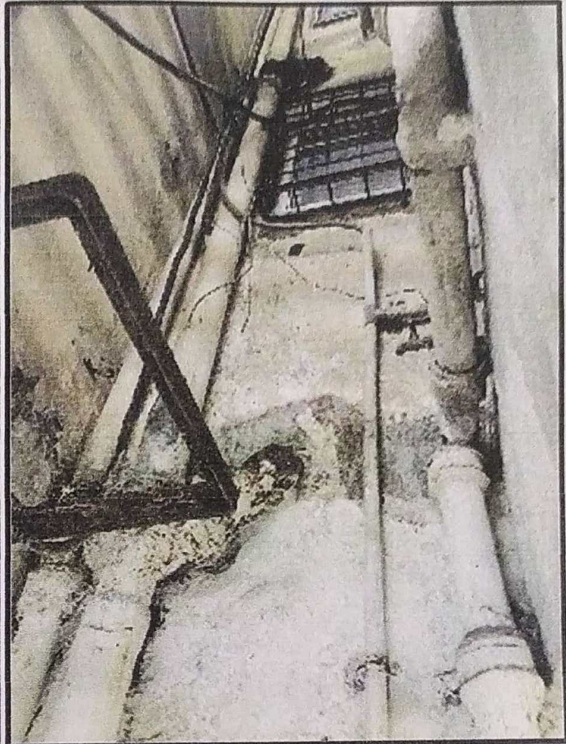
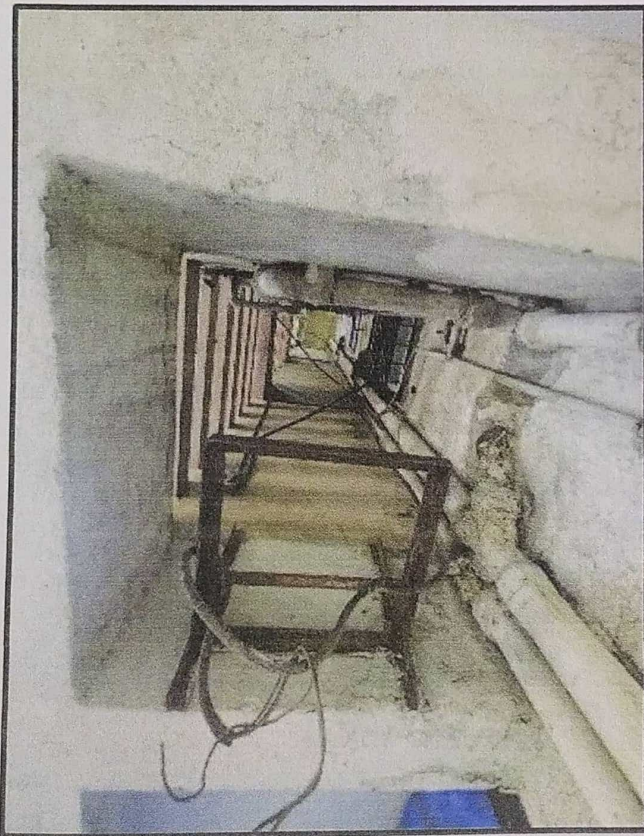
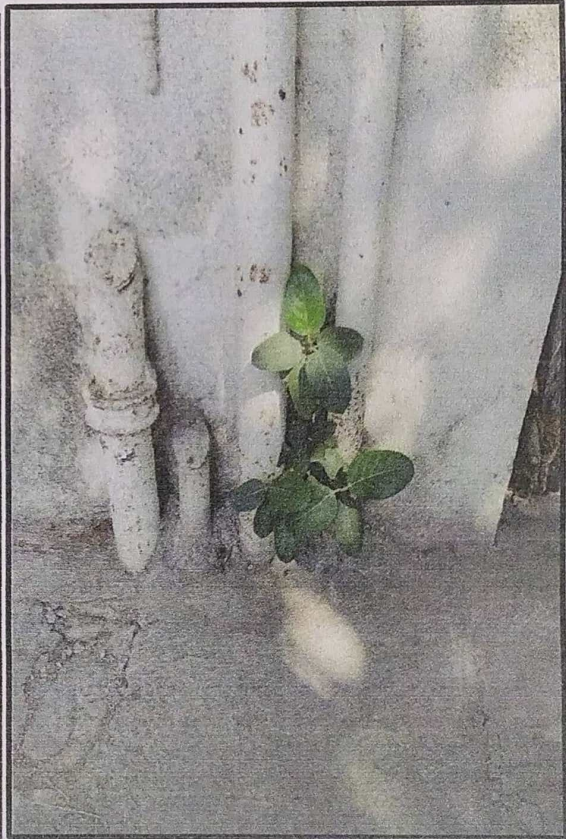
➤ PLUMBING JUNCTIONS AND DUCTS

1- Almost all the water down take GI pipes and the CI drainage piped are damaged.
